Test Report No. 7191079843-MEC14/2-YWA
dated 06 Feb 2014

Fire propagation test on "SMARTBOARD" Fiber Cement Board material submitted by SCG Trading Co., Ltd on 15 Jan 2014.

To determine the Index of Performance of the material when it is exposed to the conditions of the test specified in British Standard 476 : Part 6 : 1989 + A1 : 2009 "Method of test for fire propagation for products".

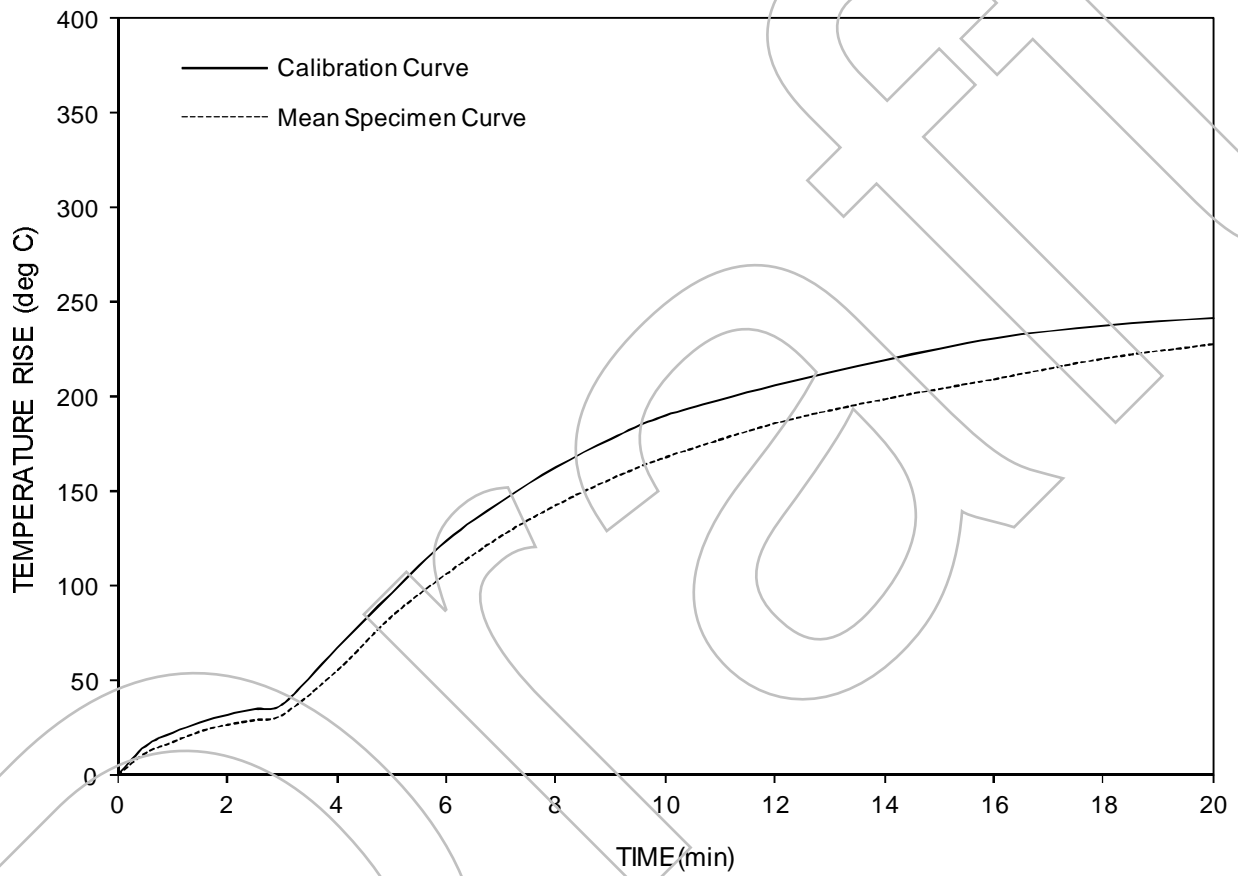
The mean temperature rise above ambient obtained from three specimens is also shown in Figure 1 (i.e. with the actual calibration curve). The mean temperature readings for the material and the calibration curve were obtained at the following intervals from the start of the test: at 1/2 minute intervals up to 3 minutes, at 1 minute intervals from 4 to 10 minutes, and at 2 minutes intervals from 12 to 20 minutes.

FIGURE 1 : COMPARISON OF MEAN SPECIMEN AND CALIBRATION CURVES

The calibration and test procedures were as defined in paragraphs 8 and 9, respectively, of the specification. The apparatus was calibrated prior to test and the actual calibration curve obtained is shown in Figure 1 of this report.
