**Test Report No.** 2763919

**Client : The Siam Fibre-Cement Co.,Ltd.**  
**1 Siam Cement Road, Bangsue Bangkok 10800 Thailand**

Sample Description : SCG Smart BOARD  
 Sample No. : 2849873  
 Sample Condition : Sample is contained in a plastic bag.  
 Quantity Submitted : 1 pc  
 Sample Receiving Date : 5-Aug-2014  
 Testing Period : 05-Aug-2014 to 06-Aug-2014  
 Test Method : (1) Asbestos - EPA 600/R-93/116  
 Test Results : Please refer to next page.

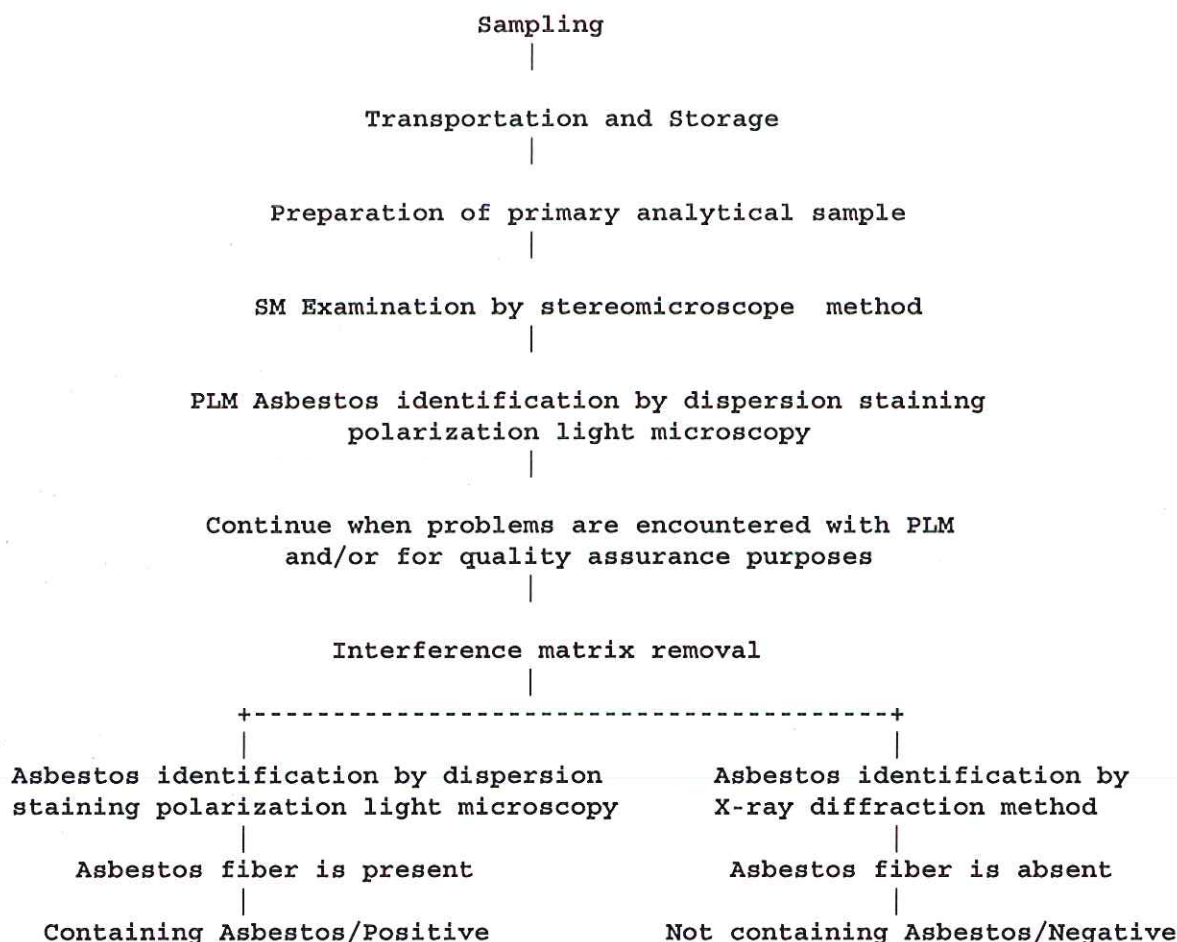
## Analysis flow chart for determination of Asbestos

Test Method : With reference to EPA 600/R-93/116 method. Analysis was performed by SM and PLM
